# PRELIMINARY REPORT

## HIGHWAY

### HWY16FH018

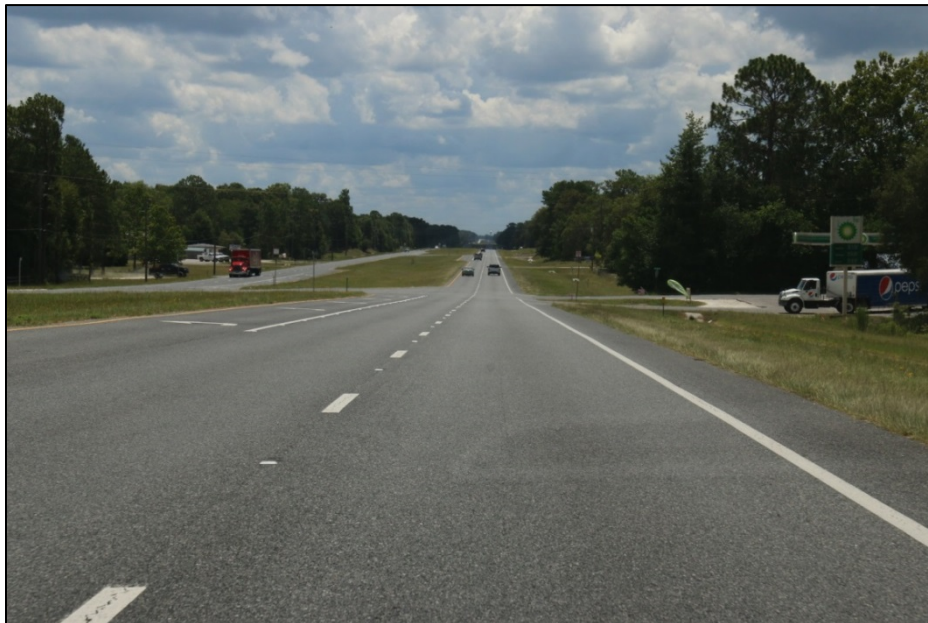
US-27A is a four-lane highway with a posted speed limit of 65 mph. A 75-foot-wide median separates the two eastbound lanes from the two westbound lanes. Additionally, at the uncontrolled intersection with NE 140th Court, both eastbound and westbound lanes incorporate left turn lanes, allowing for a median opening of about 132 feet. At the time of the crash, it was daylight with clear and dry weather conditions. Figure 1 shows the crash scene intersection.

**Figure 1.** Crash scene intersection, looking east.

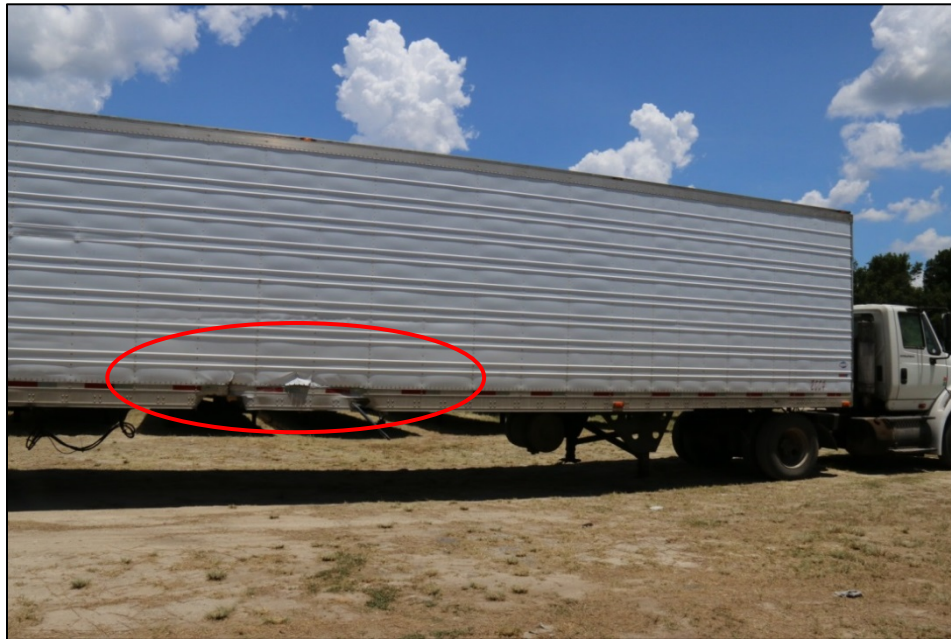
The combination vehicle—operated by Okemah Express, LLC—was transporting blueberries to a local produce farm. The Tesla struck the right side of the semitrailer, approximately 23 feet forward from the end of the trailer. Damage from the collision was consistent with a 90 degree angle of impact. Only minor damage above the height of the car was found on the semitrailer side panels, and the undercarriage of the trailer also showed only minor collision damage. Figure 2 shows the right side of the semitrailer at point of impact.

**Figure 2.** Right side of semitrailer. Area in red oval highlights collision damage from passenger car.

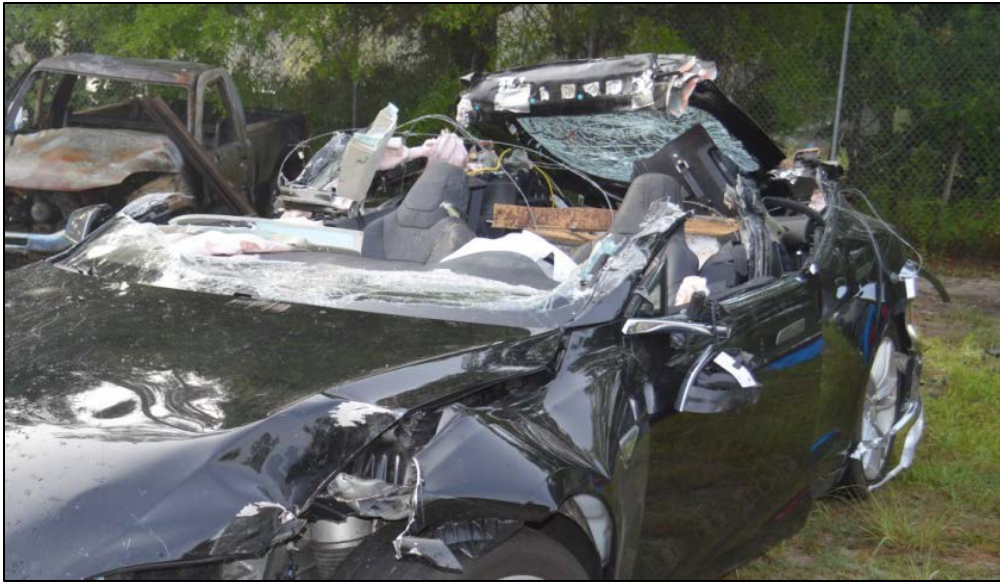
As a result of the crash, the rear hatch frame separated and folded back over the crushed rear window. Other than the roof structure—and the front bumper components that engaged the pole—the main body of the car was generally intact, as shown in figure 3.

**Figure 3.** Passenger car damage from impact with semitrailer. (Source: Florida Highway Patrol.)
